Water Resources Department

January 24th, 2017

Re: Wallowa Dam (W-2) – Inspection Summary

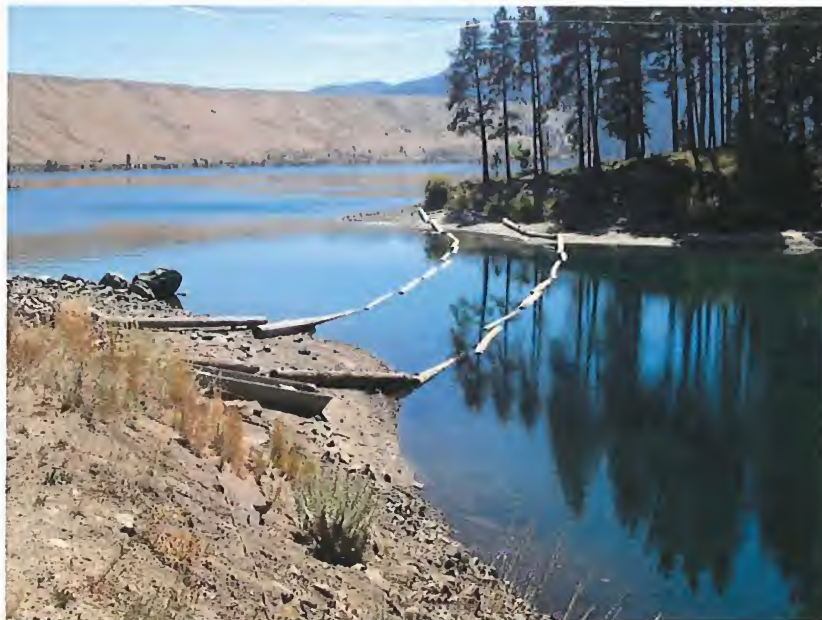
Log booms upstream of the dam

This reservoir has water surface elevation restricted at 4375 feet. However, similar to previous years, in June of 2016 the Associated Ditch Company was granted a temporary increase in the water level to 4377 feet. At the time of the inspection, the reservoir level was at an elevation of 4371.05 feet, based on the gage reading, nearly 4 feet below the restriction. At the time of the inspection, the reservoir was clear and contained no logs or other floating debris.

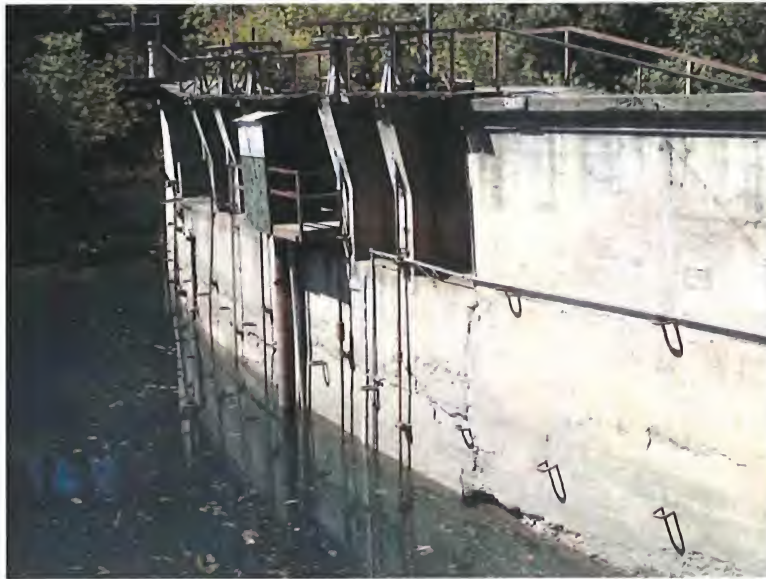
Upstream face showing deteriorating concrete

The dam and its appurtenant structures continue to deteriorate with time. As a result, the dam is near the end of its design life. The concrete on all areas of the dam is spalling and cracking. Of particular concern is the concrete on the upstream face. As noted in previous inspections, there is a band of concrete that is weak and easily removed when struck with a hammer.

1. The dam needs to be rehabilitated or replaced very soon. The process for rehabilitation/replacement can be lengthy so the process should begin as soon as possible.
2. Re-attach the steel liners in the outlet tunnels.
3. The gates for the outlet tunnels will most likely not last that much longer. If these fail, you will lose the ability to store water. As a result, these will need to be replaced in the near future.
4. Until rehabilitation/replacement, continue to operate this dam as per the restriction we have previously established and continue to enforce.

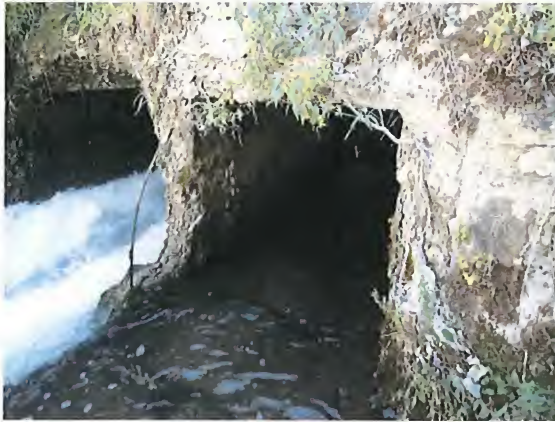
Gate tunnels 5 (open) and 4 (closed)

There are five gates that control the flow to each of the five outlet tunnels. The gates are manually operated frequently. The conduit tunnels experience continued deterioration, delamination and spalling, and calcium carbonate efflorescence (spires) from seepage. As was the case in past inspections, the gates cannot be completely closed and leak significantly. During the inspection, the operator closed the gate valves as much as possible so that we could observe the amount of leakage from the gates. The gates are numbered consecutively starting from the left abutment. Gates 1, 3, and 5 leak when closed, while Gates 2 and 4 do not. The leakage, in cubic feet per second (cfs), through gates 1, 3, and 5 was estimated at 20 cfs, 14 cfs, and 6 cfs, respectively. At some point in the near future the leakage will prevent effective storage of water.

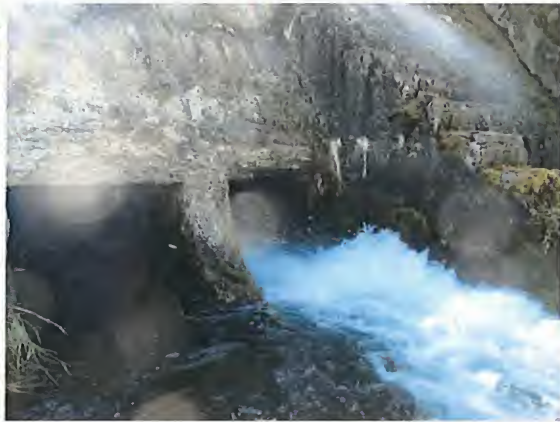
Gate tunnels 2 and 1 (both closed)

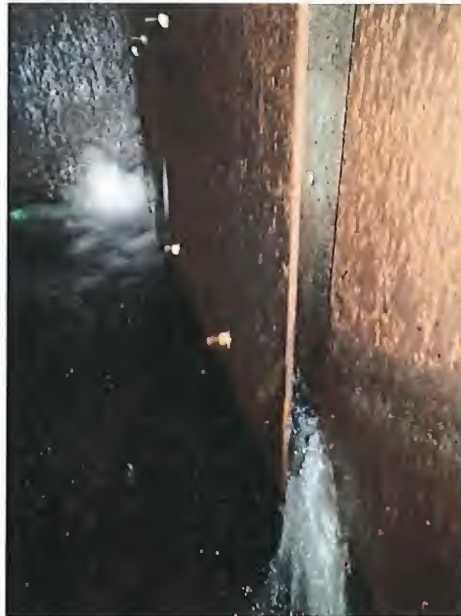
Steel plate in tunnel separating from the concrete

In addition, the steel liners that were installed approximately 20 years ago, as temporary measures, are now detaching in gate tunnels 2 and 4. Due to the leaks in tunnels 1, 3, and 5, it was not possible to determine if the liner is separating in these tunnels. However, it is likely that the liner has begun to separate because the liners in both tunnels 2 and 4 are separating.

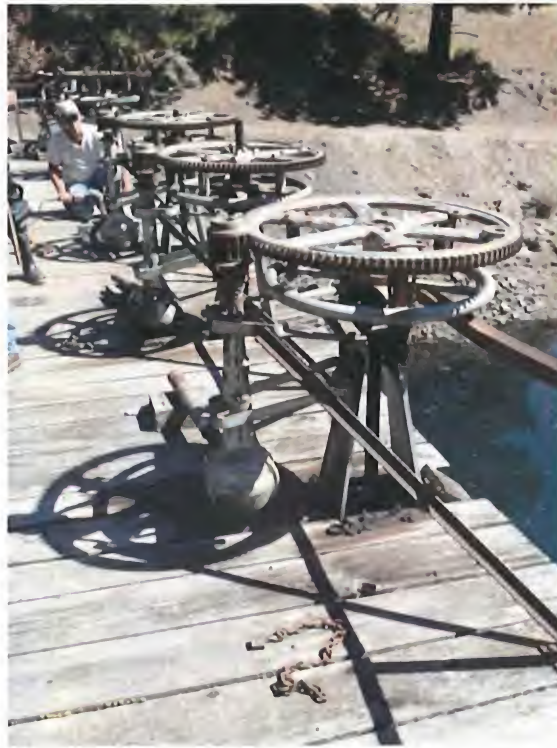
Control mechanisms for the gate valves

The control stems for most of the gate valves are bent. At the time of this inspection, the gate frames and gates themselves were still submerged and therefore not inspected. Prior inspections have noted continued deterioration of the gates and gate frames.
